Messex LiftBoy GB1 schematic Reverse engineered from PCB by John W Cook. V1.01 updated November 2018 (Updated component type for relays) This schematic is for indication only. I cannot offer any guarantee of its accuracy Use this at your own risk

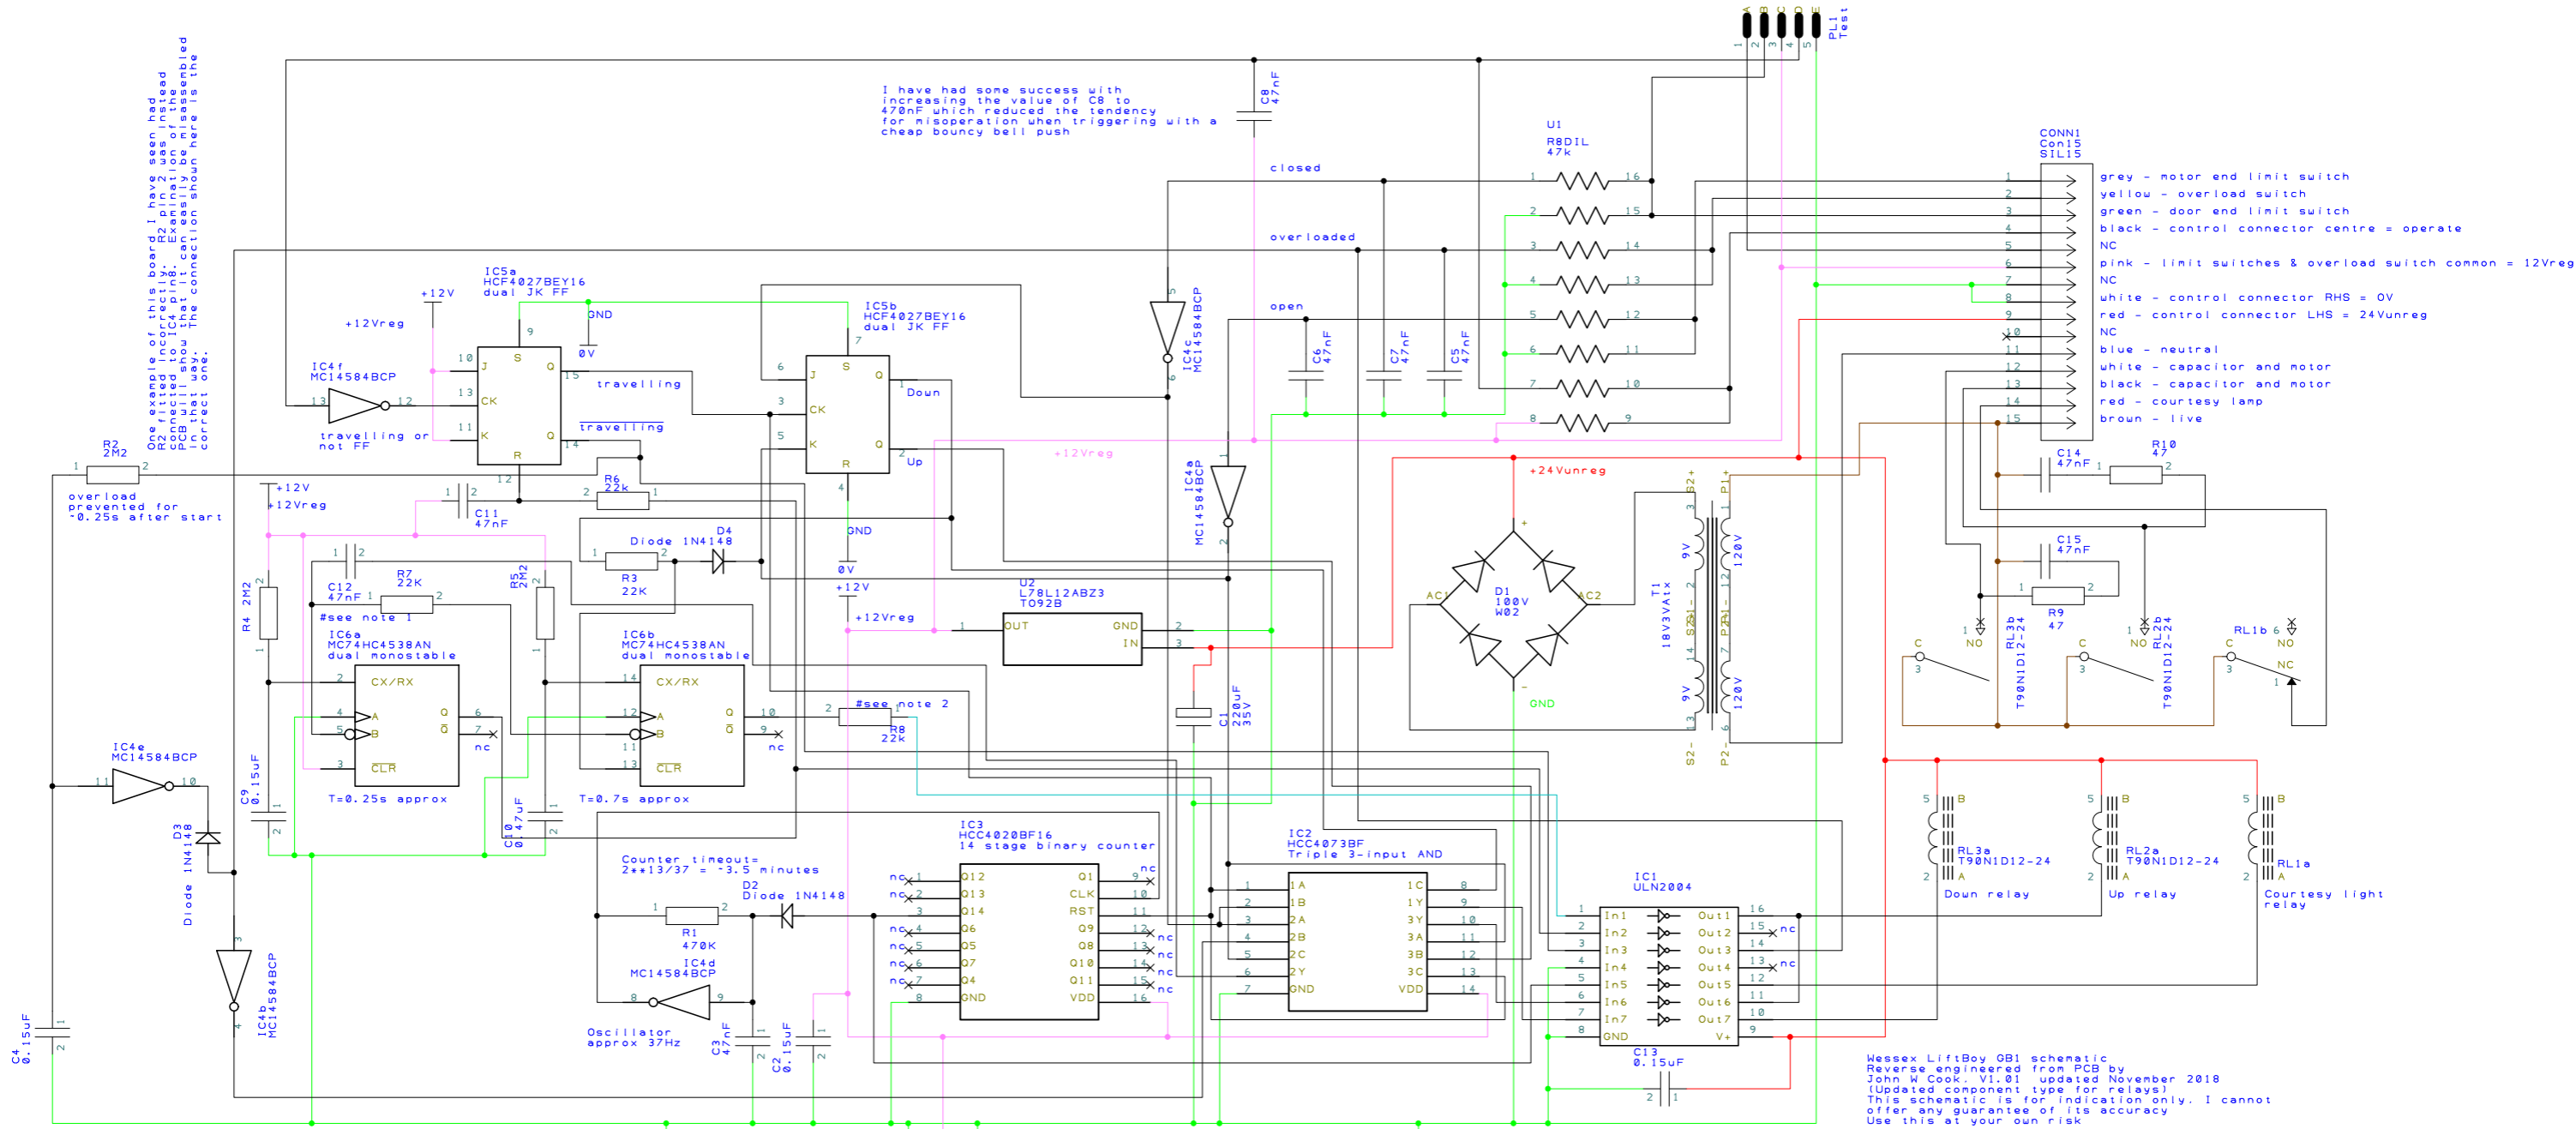
One example of this board I have seen had the motor end limit switch connected to the wrong terminal. The PCB will show that it can easily be misassembled in that way. The connection shown here is the correct one.

#Note 1
There is a problem with this node (clock node for monostables). It is floating at dc. I thought this was a fault with my pcb tracing but I've rechecked many times and I'm pretty sure this is true. This is very bad practice and makes circuit operation unpredictable. R7 seems to serve no particular purpose. Probably the intention was for it to be a bias resistor but instead it is useless in series with one of the monostable's clock input.

#Note 2. R8 also seems to serve very little purpose. There is already an input resistor integrated inside the ULN2004 driver.

I traced this board when diagnosing a fault. The fault turned out to be RL3 contacts not mating. At time of writing can buy these relays for £1.95 from Farnell

I have had some success with increasing the value of C8 to 470nF which reduced the tendency for misoperation when triggering with a cheap bouncy bell push
